Safety Alert

Tipping areas and bucket changing

21 August 2024

NHa353

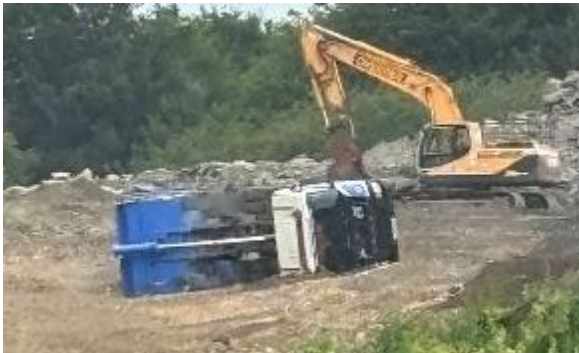
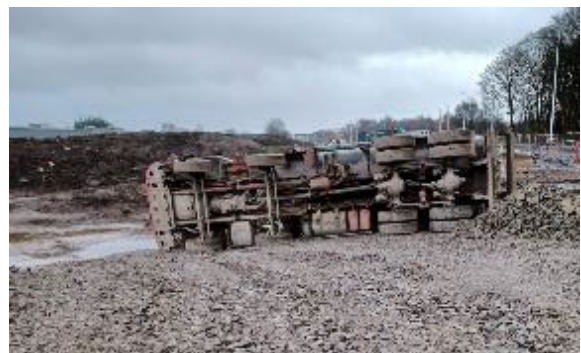
INCIDENT (1) – TIPPER LORRIES.

We have unfortunately had 2no tipper lorries go over onto their sides recently – one with no injuries to the driver and one that ended being RIDDOR reportable. Ground conditions played a fundamental part in the root cause analysis of both incidents along with an unbalanced load that the driver had tried to 'shake free'.

Tipping areas should be managed in the same way as any other part of the site and should be level, firm and stable, with the tipping area able to hold the vehicle and load during tipping. It should be clear of overhead lines and services, and away from pedestrian walkways. The vehicle should remain level at all times, even if it is driven forward during tipping. Articulated vehicles must be tipped with the cab and trailer in line.

No one should be permitted to stand or walk behind the vehicle when the body is raised or during tipping, and when raising or lowering the body, the driver should never leave the vehicle and should make sure that the cab doors are closed.

Drivers should be experienced enough to anticipate loads sticking and must never drive in order to shake free a stuck load. If the load does stick, the body must be lowered, and the load freed before the body is raised again. The driver should always make sure that the body is completely empty after tipping and should not drive more than a few metres forward to make sure the load is clear, and should only do this after checking the load is at the bottom of the tipping body.

Wheel-stops must be used when possible to help position vehicles.

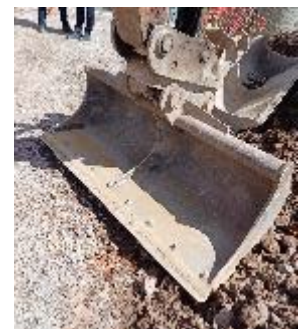
INCIDENT (2) – BUCKET CHANGING

During the changing operation involving a 13T excavator and ditching bucket, the driver accidentally knocked the bucket into an adjacent shallow excavation, causing injury to an operative in the excavation. The operative suffered no broken bones but was off work for more than 3 days, making it RIDDOR reportable.

Sites should have dedicated bucket changing areas away from workers, pedestrians, walkways, services or other plant and equipment that could be damaged. Areas should be identified and not used for other purposes. They should be clearly marked on the site Traffic Management Plan and referred to in the associated and relevant RAMS. Unauthorized persons should be excluded from these areas during bucket changing operations.
