Derby Road Bridge

Beam Design & BIM Integration

25th February 2025

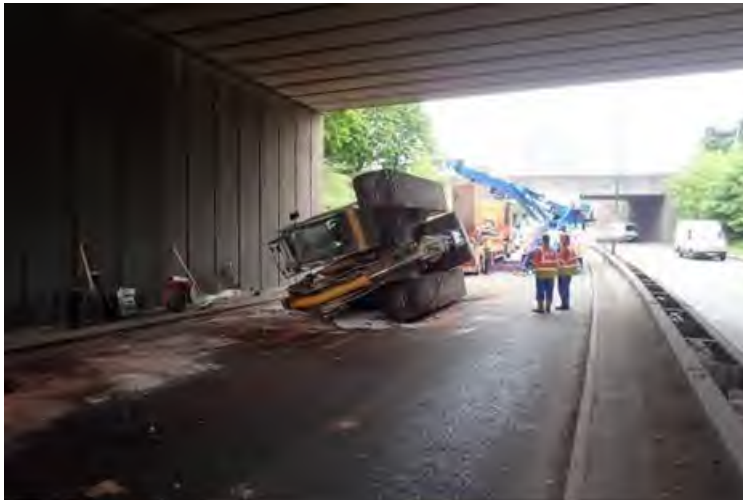
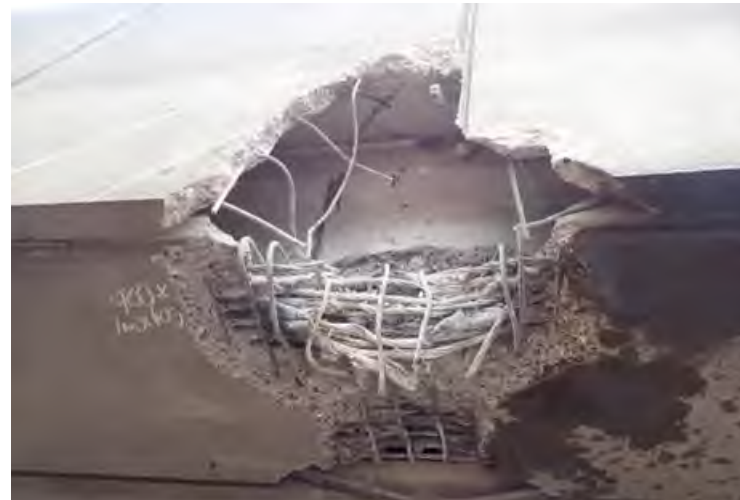
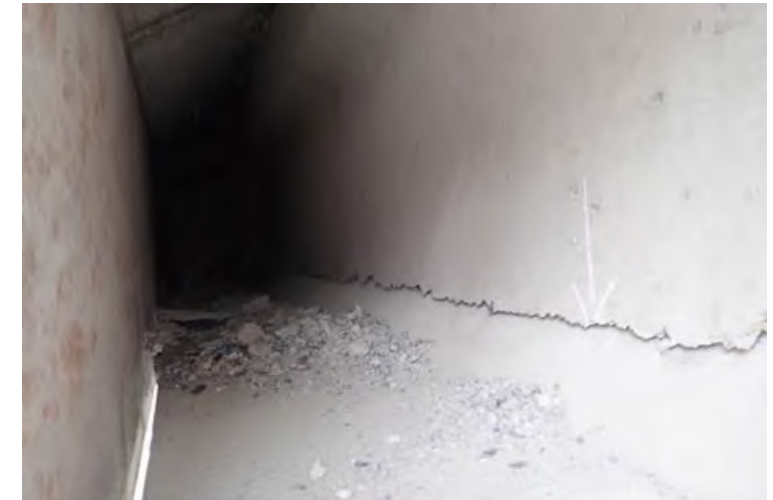
- Impact occurred on 5th of June 2018.
- It involves an excavator on the back of the trailer
- Caused severe damage to the northern precast pre-tensioned beam, and 2no. Precast concrete cladding panels.
- Severed, damaged and split tendons with the surrounding reinforcement stirrups deformed.
- Secondary shock waves running through the beam have caused the web to become hollow and spall.

The impact damage to the prestressed edge beam is severe, exposing nearly all the bottom flange tendons. At the point of impact, the tendons are severed, deformed and split with surrounding reinforcement stirrups deformed. The web has spalled at the point of impact and a longitudinal crack of undetermined length exists at the lower flange / web interface. A second 1.3 m long crack exists above the point of impact, at the upper flange / web interface.

- Demolition of the damage edge beam and existing parapet
- Construction of a new edge beam, and parapet
- Waterproofing of the deck
- Reinstate the bridge to its original state

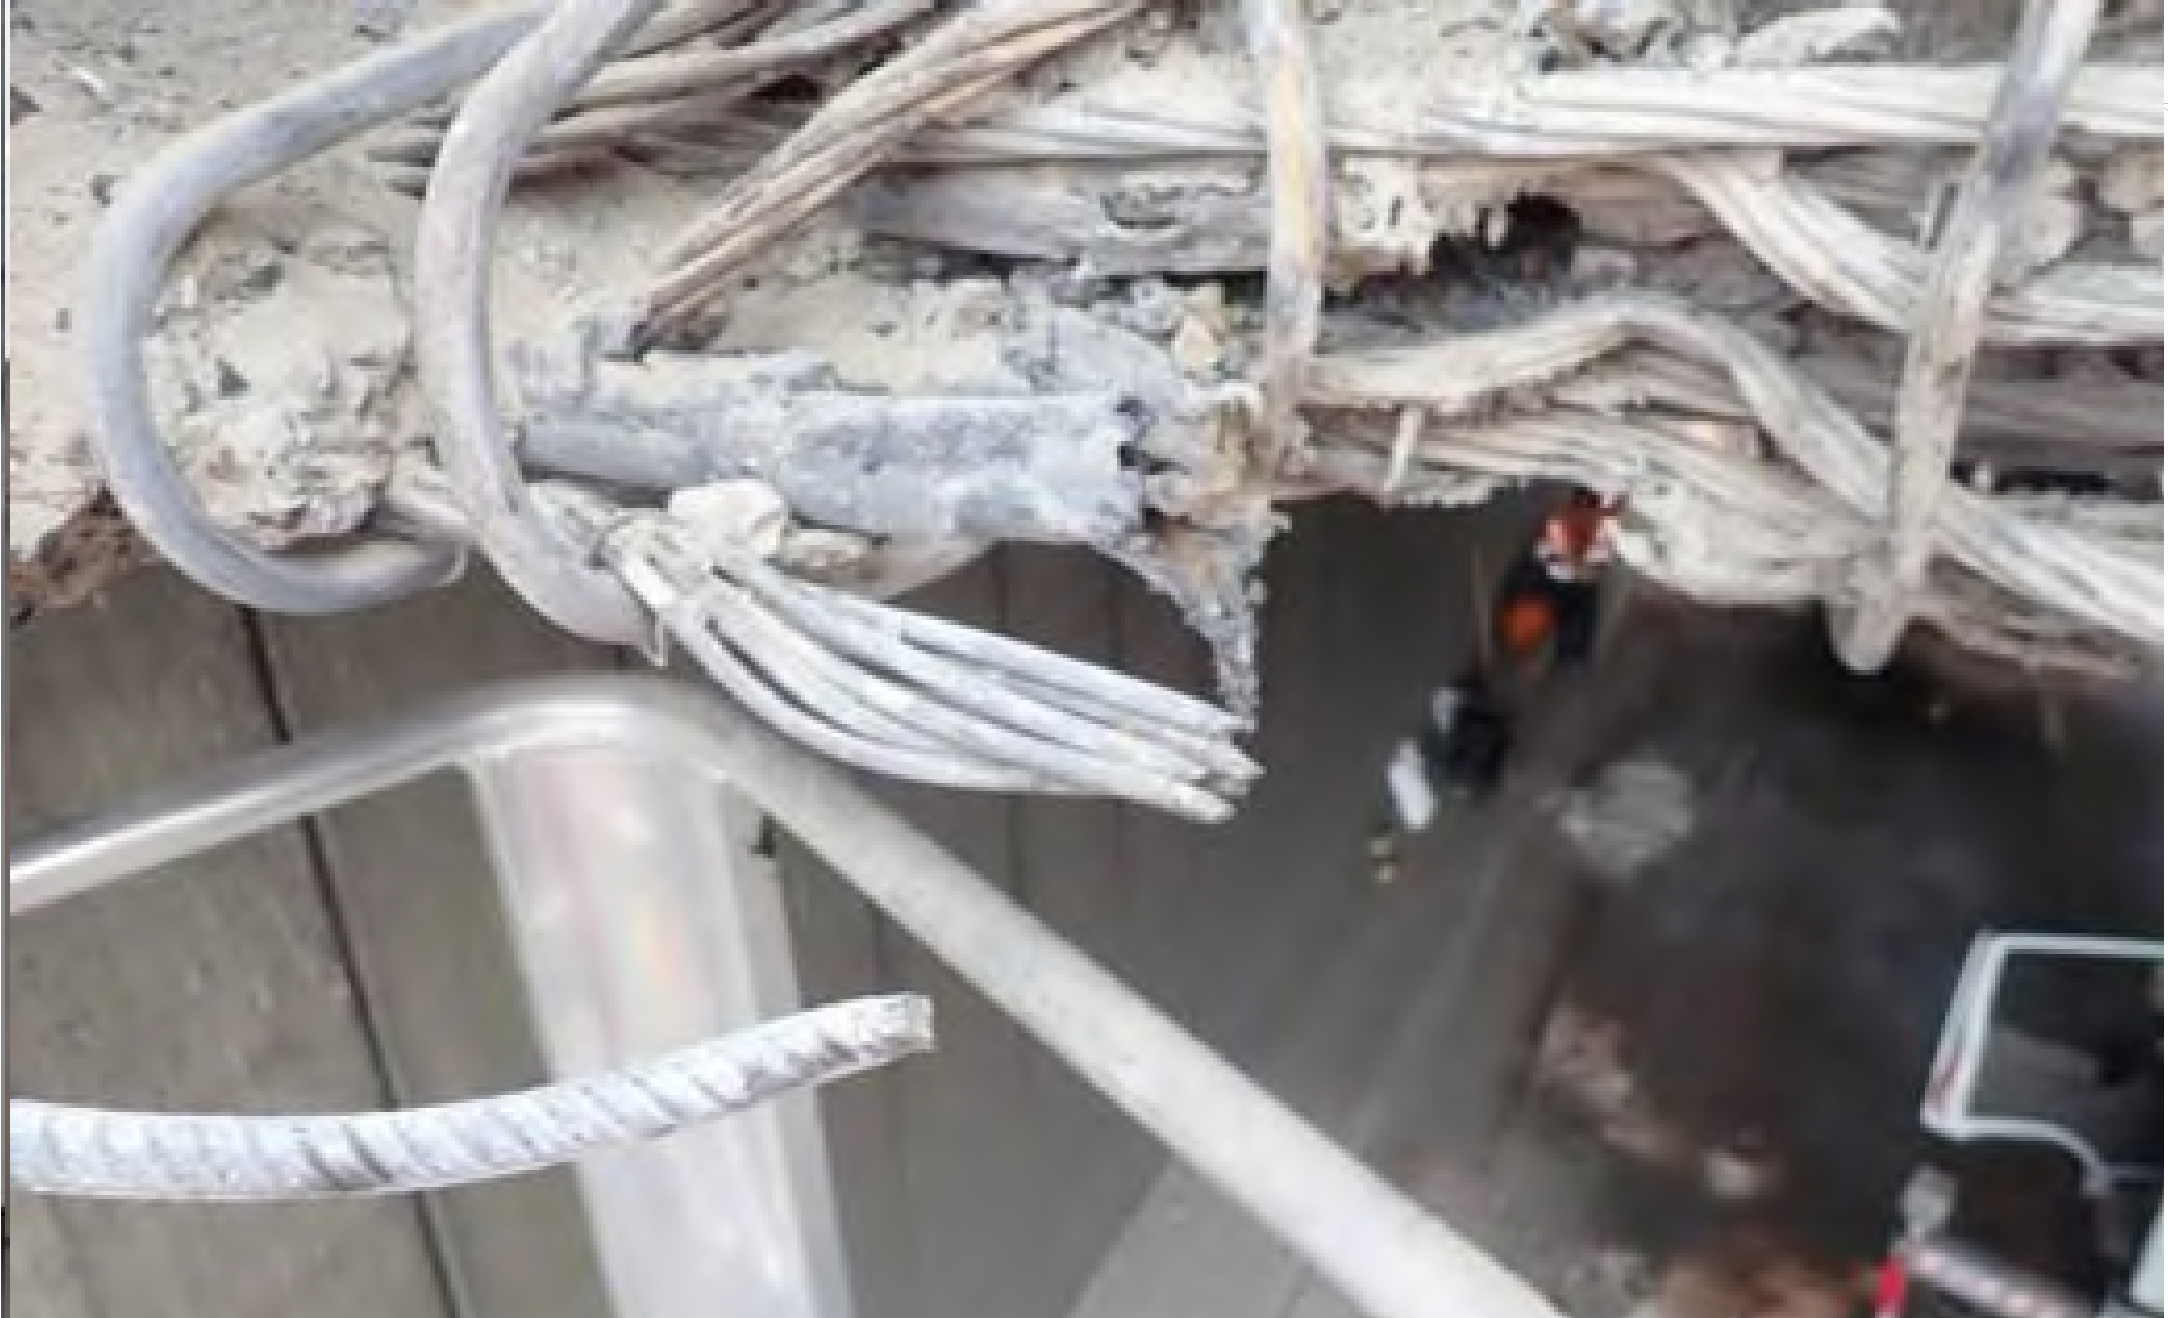
Split tendon in the bottom flange of the main beam

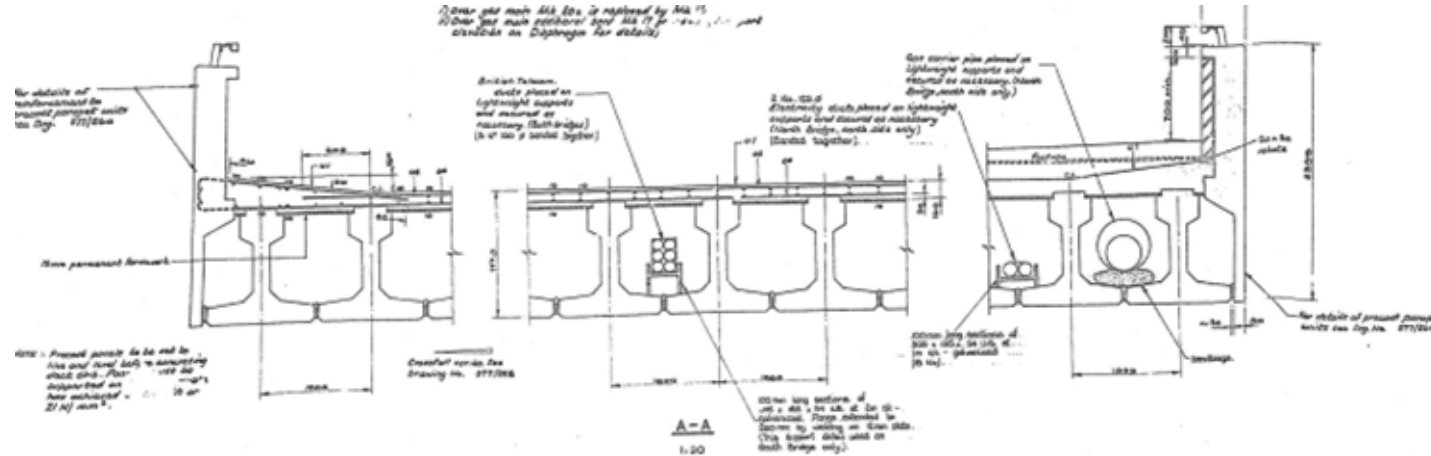
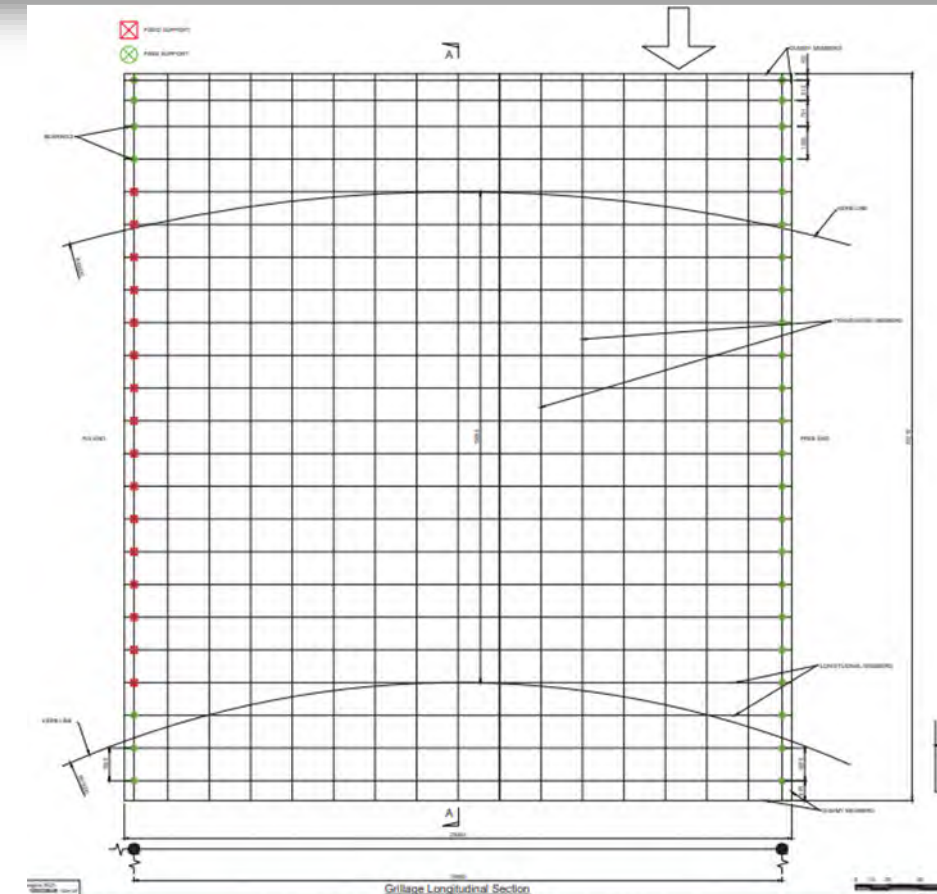
Considering the above damage the section properties of the damaged beam were only considered to consist of the upper flange and deck.

- Damage Edge Beam

- Fail in bending under permanent Dead Load
- Failure does not result in collapse of the edge beam. The transverse slab provides support
