Remote Sensing – What do we do with the data?

Gloucester Bridges

Vinci Construction UK Technical Services
General Inspection Report – Brockweir Bridge
GCC-TW-XX-XX-RP-C-000004
Rev 2

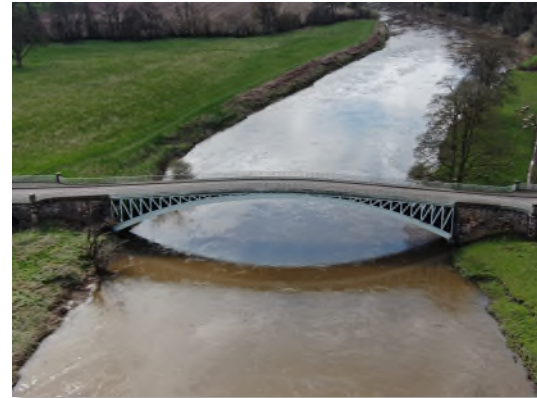
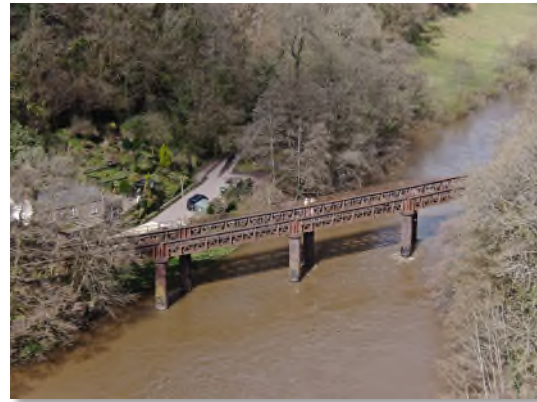
- Purpose: Capture data across 4 separate locations
- Goal: Timely data collection
- Requirement: No need for specialist access teams
- Activity: Conduct a general inspection
- Outcome: Generate a comprehensive condition report
 - Coverage: Above and below the waterline

- Deploy Remotely Operated Vehicles (ROV) for data capture from the air and the river.
- Aerial capture using Unmanned Aerial Vehicles/Drones (UAV) consisted of photos and videos for visual inspection of structures and photogrammetry processing.
- Waterborne ROV to capture the riverbed using multi beam sonar , processed into DSMs to accurately assess conditions and feed into overall report

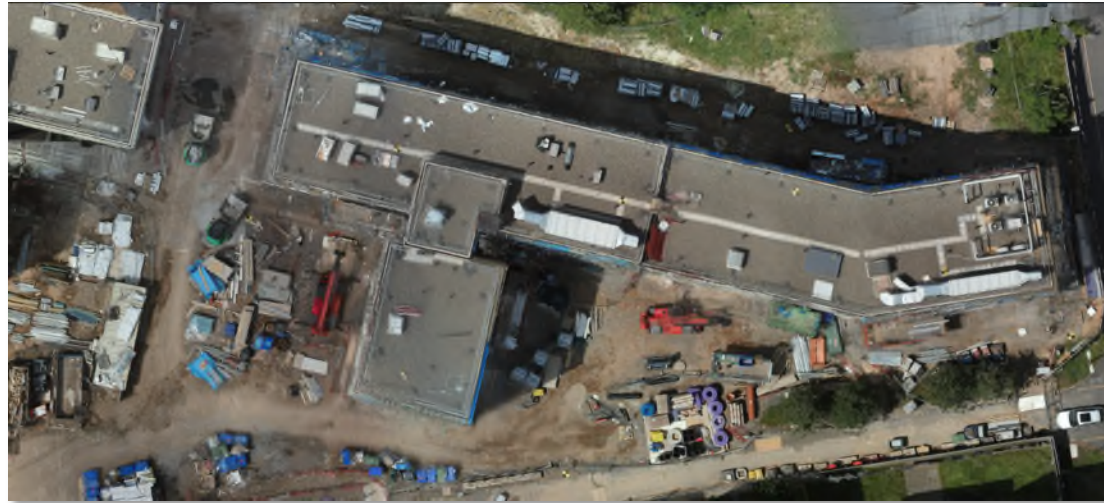
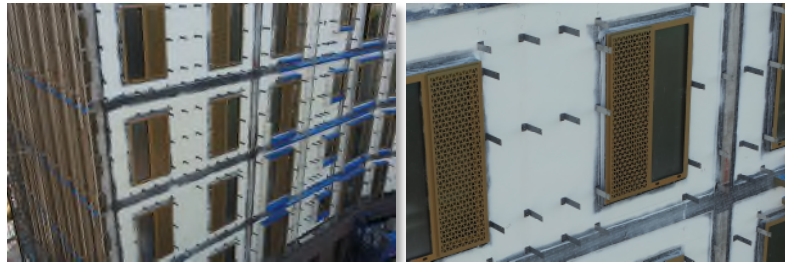
‘Manually verifying the installation of cladding brackets is a time consuming and costly exercise that put our operatives in harms way.’

Create a digital twin of the site using hi-res imagery captured from a UAV.

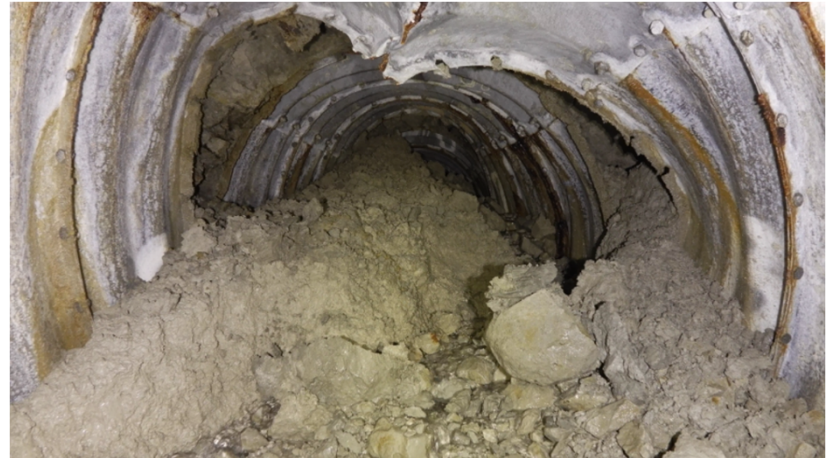
- Same day deployment to site for multi sensor capture.
- Capture the entire area in photo and video for modelling
- Laser scan the adit portals
- Scan video and photograph the adits with caged UAVs
- Create a base model for future site comparison
