Derby Road Bridge

Beam Design & BIM Integration

25th February 2025

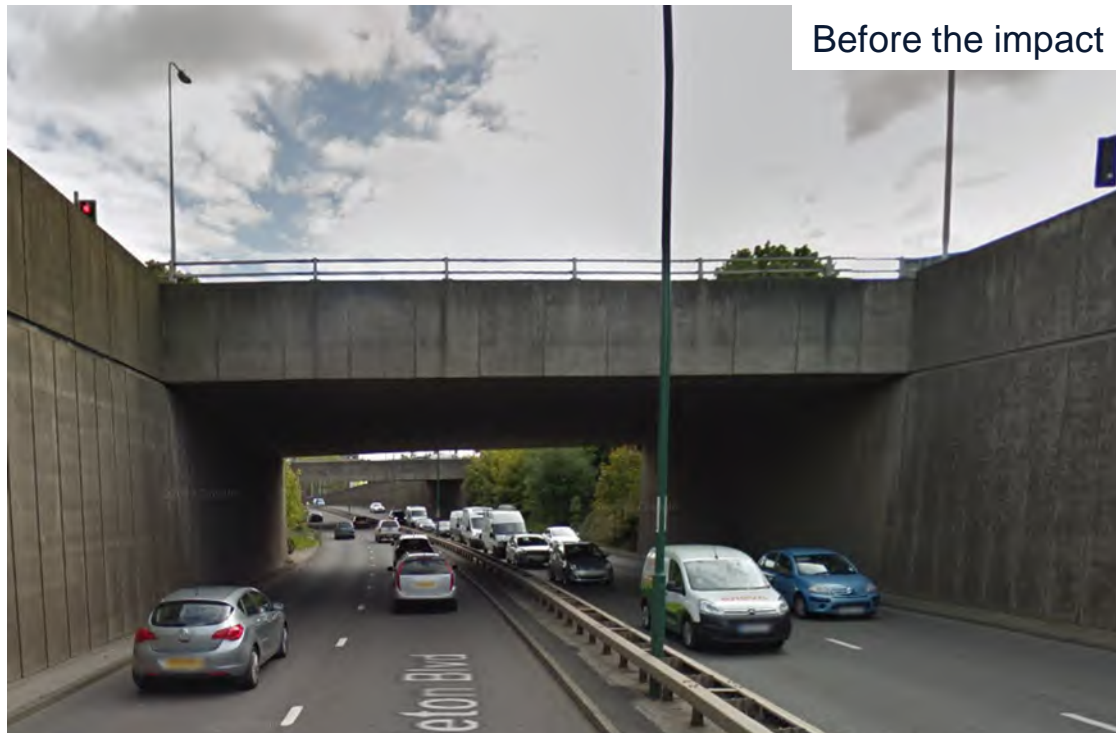
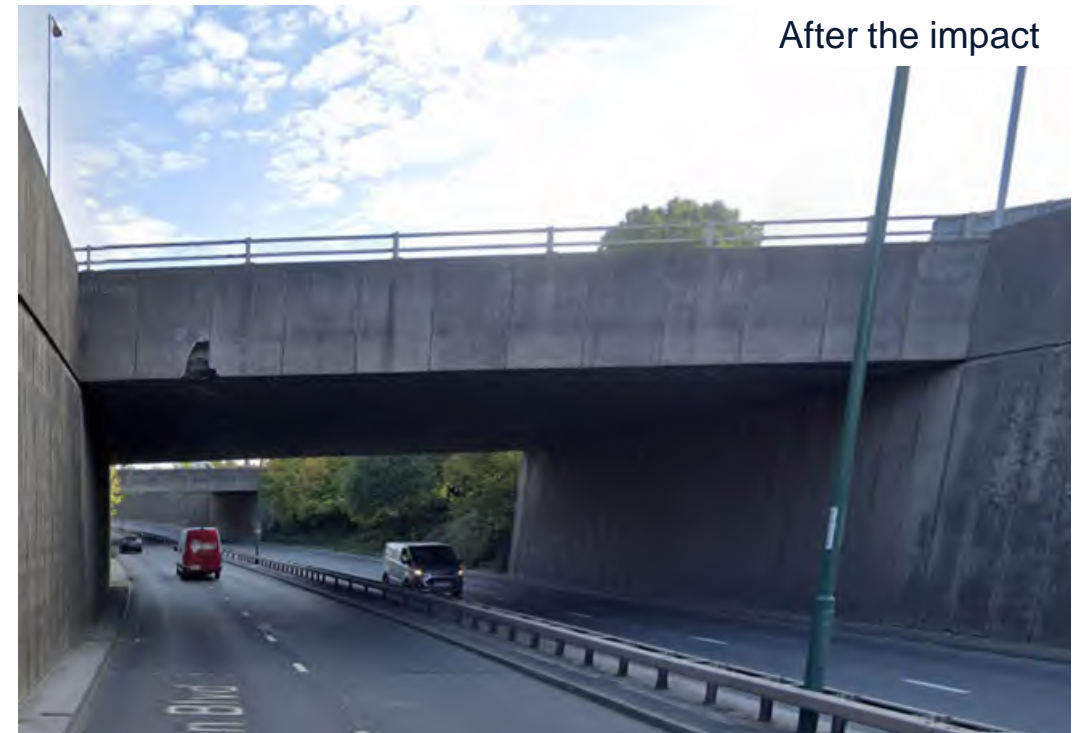
- Impact occurred on 5th of June 2018.
- It involves an excavator on the back of the trailer
- Caused severe damage to the northern precast pre-tensioned beam, and 2no. Precast concrete cladding panels.
- Severed, damaged and split tendons with the surrounding reinforcement stirrups deformed.
- Secondary shock waves running through the beam have caused the web to become hollow and spall.

The main elements of the project were:

- Demolition of the damage edge beam and existing parapet
- Construction of a new edge beam, and parapet
- Waterproofing of the deck
- Reinstate the bridge to its original state
